Fancher Creek Bridle Trail

Fresno County

February 1, 2019

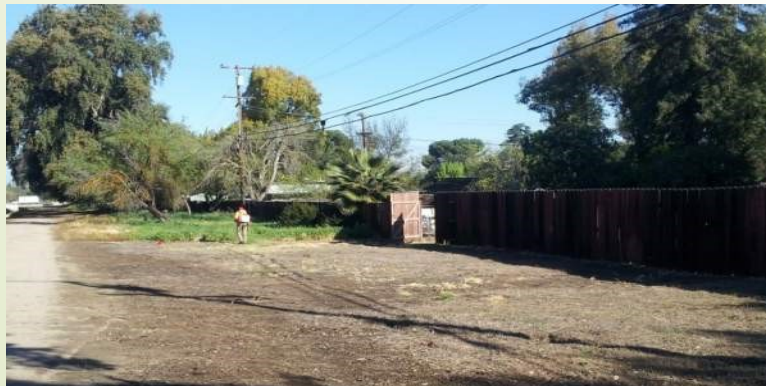
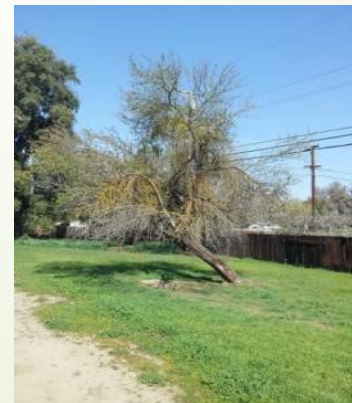
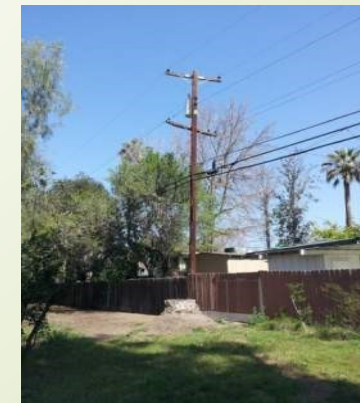
Existing Conditions

- ▶ The landscape plan from the 1950s included mostly non-native trees and reflected what was popular at the time. They include trees such as American Elm, Cork Oak, Eucalyptus, Acacia, Coast Live Oak, Locust and Carob. Other trees colonized, have been bird seeded or planted by residents. Trees range in age from 15 to more than 75 years.
- ▶ There are other resident established plants such as vines, shrubs, hedges, and fruits trees.
- ▶ In the past 5 years SPOA, Tree Fresno, High Sierra Volunteer Trail Crew with assistance from the County of Fresno have participated in the effort to clean up the Fancher Creek Bridle Trail. With major progress in the clearing weeds, and downed and unwanted trees in and around critical areas.

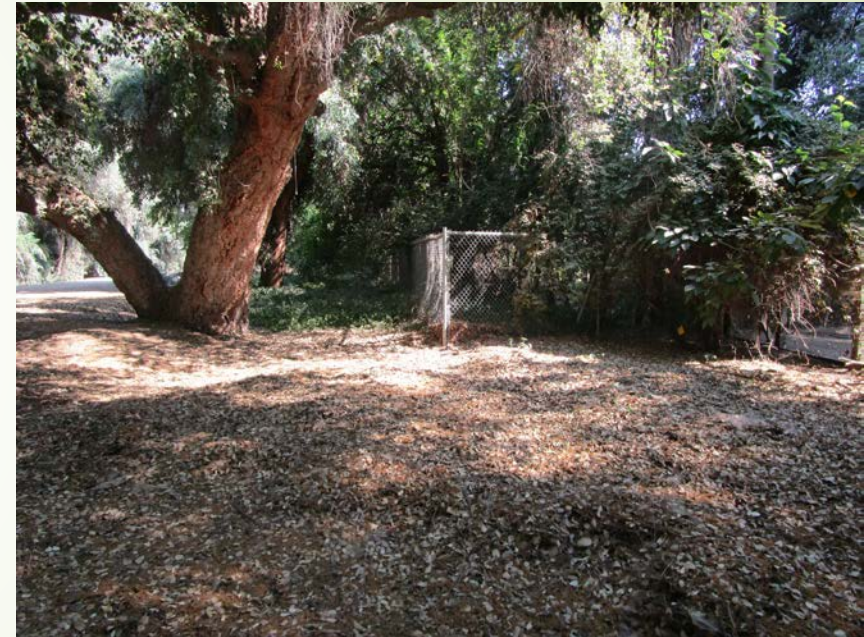
Encroachment

- ▶ ENCROACHMENTS
 - ▶ Adjacent properties owners have encroached into the FCBT easement
 - ▶ Encroachments vary from minor 6" encroachments into the easements to major encroachments 15' into the easement.
 - ▶ Efforts have been taken to minimize impacts to encroaching property owners. Despite our best efforts a few encroaching property owners will be impacted. This is due to the fact they severely encroach on and impede the trail path. They have been contacted and have been given time to correct issue.

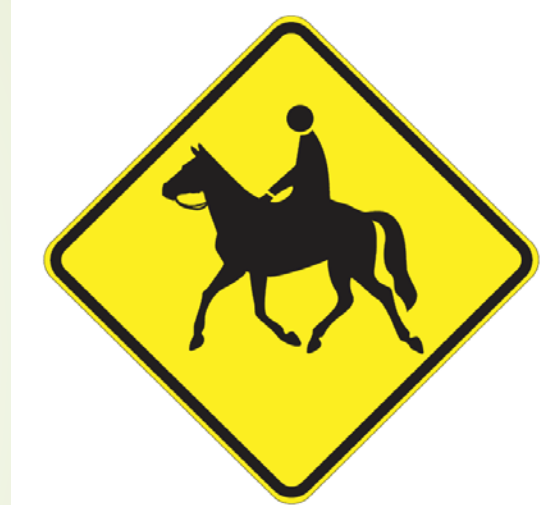
Trail Design

- ▶ The bridle trail will be comprised of 4" of DG over 6" of native compacted soil. It will have a 10' wide usable surface with 2' shoulders on either side. A 10' vertical clearance will be maintained throughout the trail for horse and rider safety
- ▶ Trail length (1.37 mi)
 - ▶ Kings Canyon Ave. to Butler Ave. (.52 mi)
 - ▶ Butler Ave. to Clovis Ave. (.85 mi)
 - ▶ California Ave. alignment (.26 mi)
- ▶ Includes a new painted crosswalk at the Butler Ave. crossing
- ▶ There will be parking at the Butler Ave. crossing
